DELAWARE LAKE DAM NJ 00127

PHASE 1 INSPECTION REPORT
NATIONAL DAM SAFETY PROGRAM

AUGUST 1981

REPT. NO.: DAEN/NAP-53842/NJ00127-81/08

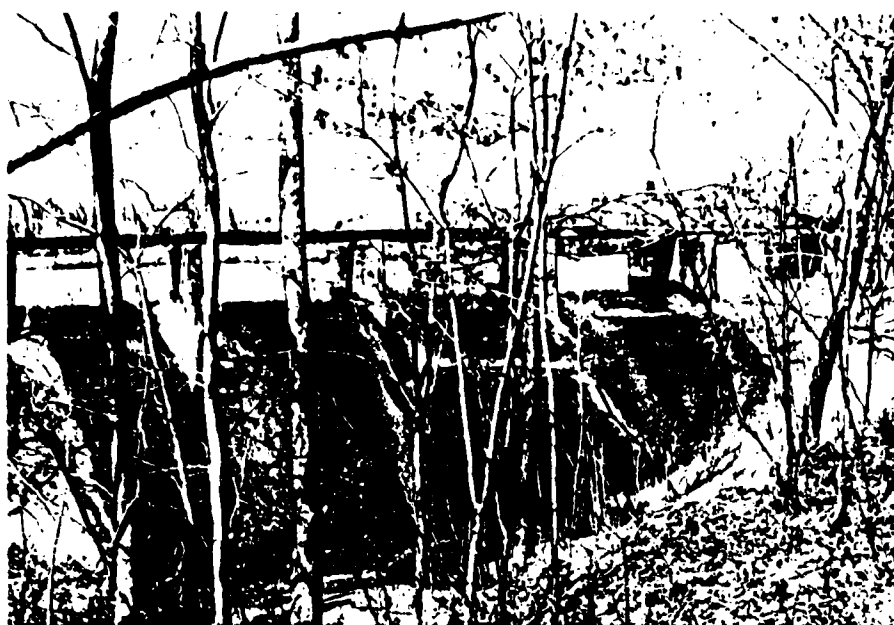
Downstream face of overflow spillway. Note repaired concrete at left (east) side (right edge of photo).

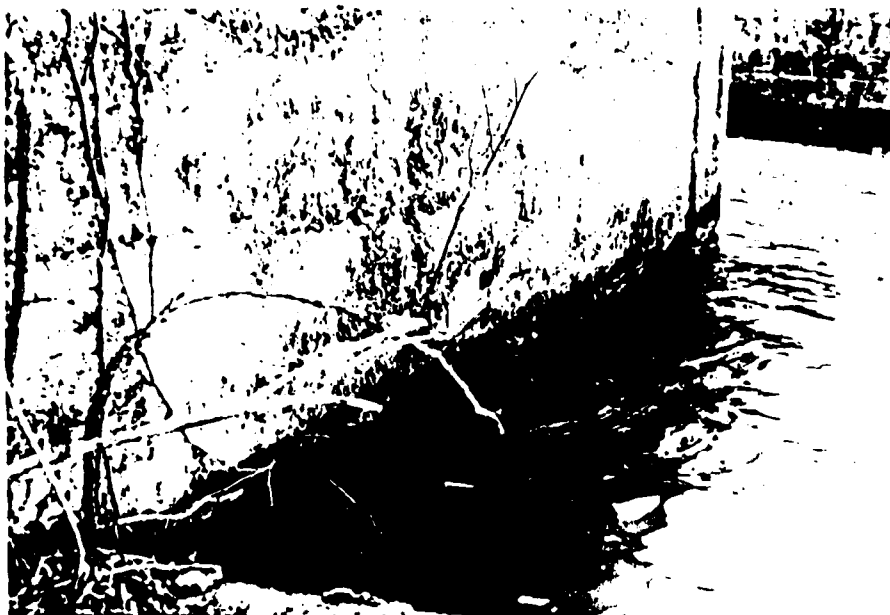
1. Ungated Spillway. The upstream end of the right spillway framing wall has cracked and the upstream end has been displaced by settlement. The upstream face of the left training wall is badly eroded at the waterline. Four vertical thru-wall cracks were observed in the right training wall downstream of the spillway. Also, the downstream end of the spillway at the junction with the downstream channel is broken. The surface of the left spillway training wall in the vicinity of crest is spalled and eroded up to 1/4" deep. The service footbridge, consisting of wideflange beam laid flat, is rusted.

Scoured and eroded concrete at water line on upstream training wall wing (left [east] side).

- e. Provide erosion protection for the toe of the dam from water flowing in the discharge channel downstream from the spillway and low-level outlet.
- f. Repair spalled and cracked concrete spillway training walls.

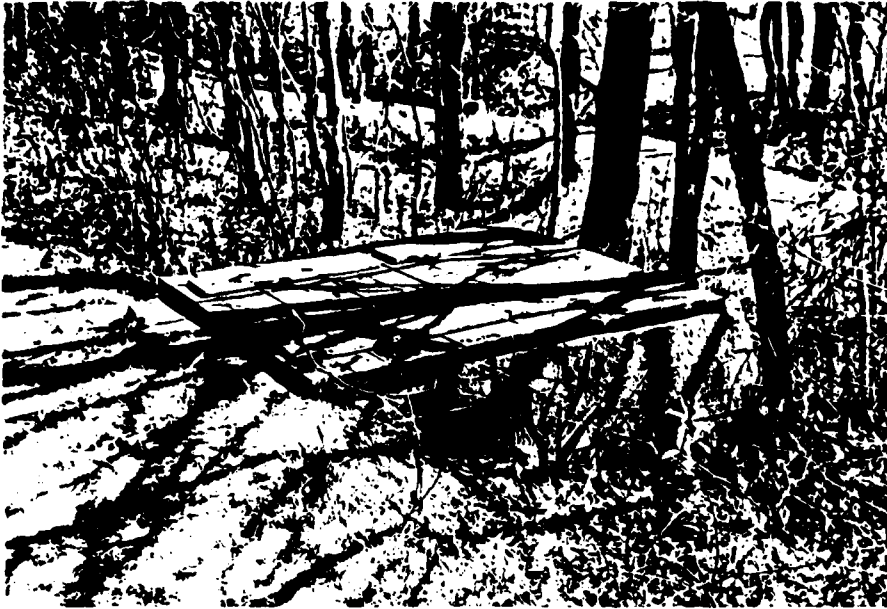
2. Low Level Outlet. The 12" gate valve was reported operable at the time of inspection. The steel ladder rungs descending into the valve pit are badly rusted. The concrete headwall at the downstream end of the low-level outlet is cracked and eroded. Erosion has occurred on the downstream slope in the vicinity of the low-level outlet.

Valve box near center, downstream, near crest. Ladder rusted and dangerous.

m. Replace the ladder rungs in the valve box. If this is not possible, remove them completely and provide other access to the gate valve as desired.
